Trouble-shooting program

BMW 528 i, 628 CSi, 728 i, 81 →

## Technical Bulletin

Danger of Accident on Semi-conductor Ignition Systems

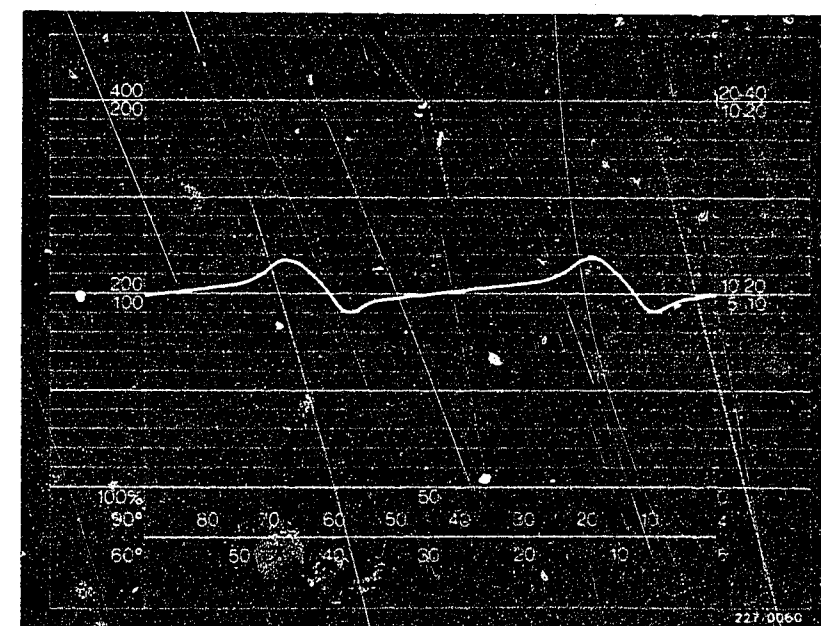
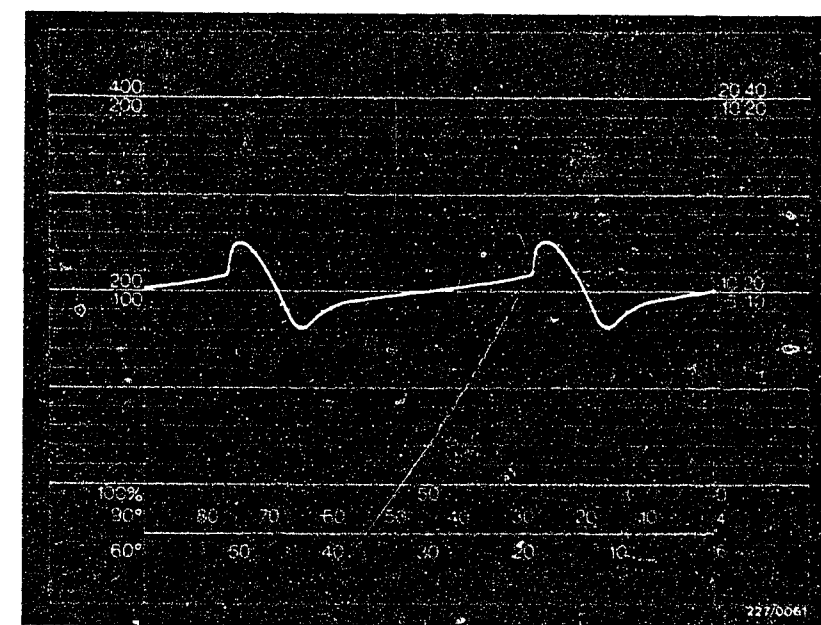
Fig. 1

It is not the level, but the curve of the pickup voltage which is important.

Oscilloscope patterns O.K.?

Replace ESV trigger box.

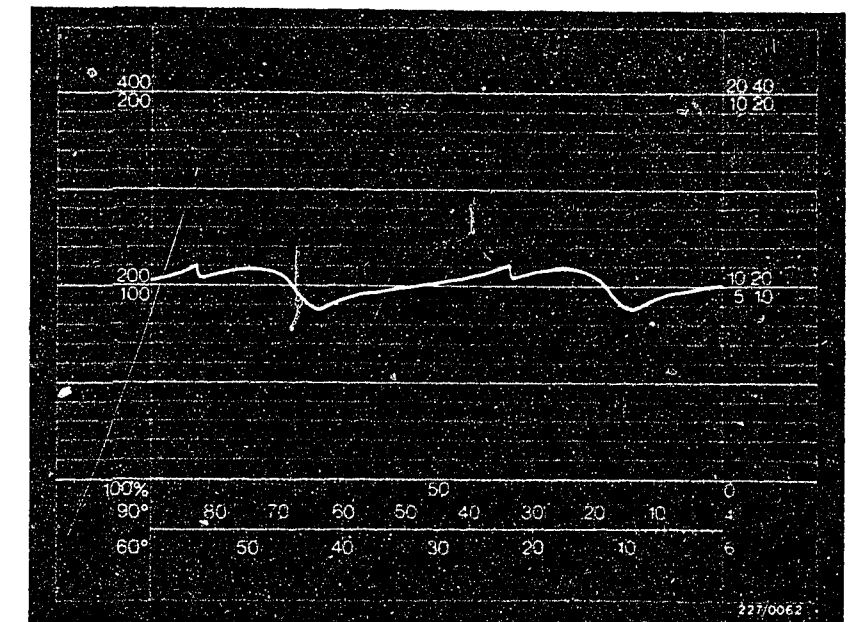
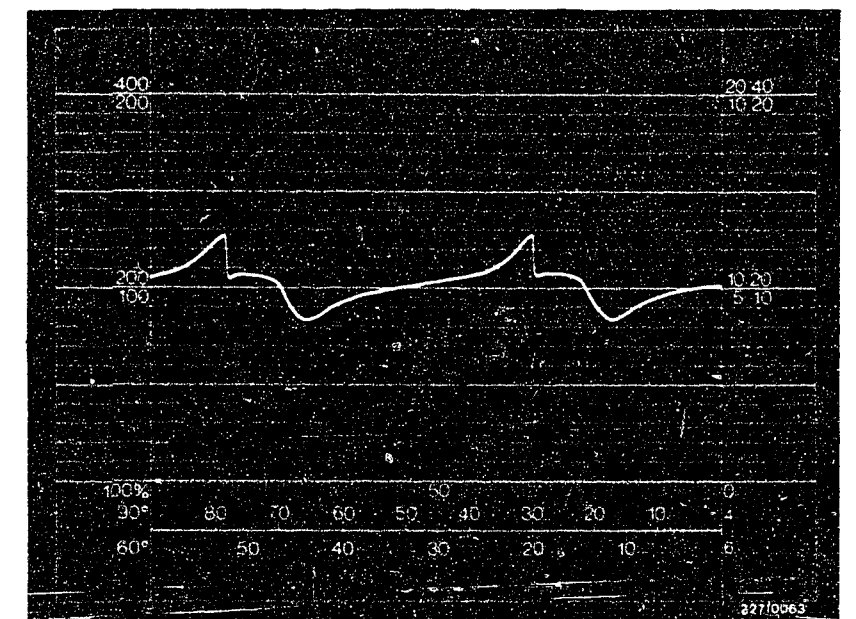
Fig. 3

Testing the electronic retard (ESV).  
Adjust the engine speed as listed  
below and compare the respective os-  
cilloscope patterns indicated with the  
nominal oscilloscope pattern.  
It is not the level, but the curve of  
the pickup voltage which is important.

Oscilloscope patterns O.K.?

Replace ESV trigger box.

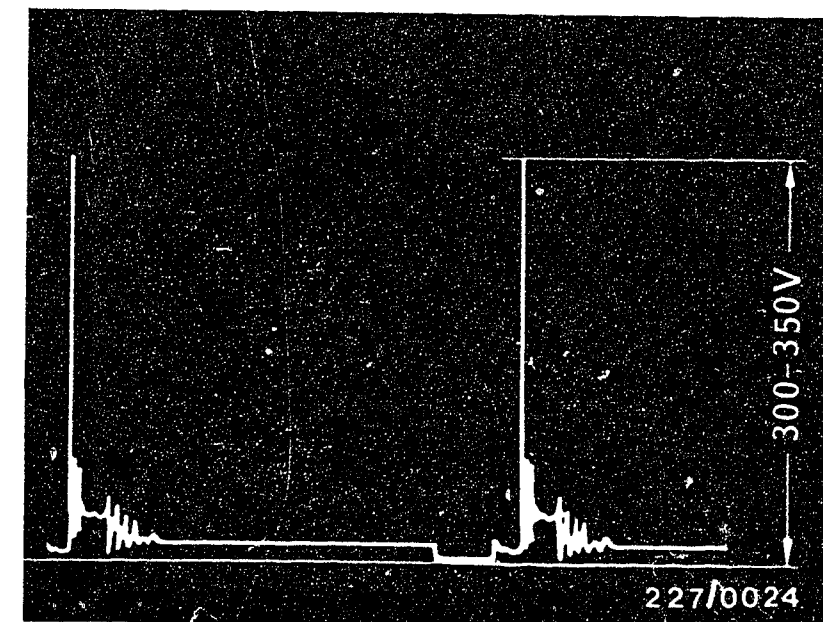
Check the primary voltage (if MOT 002.00 available).  
Connect the oscilloscope (MOT 002.00) to the ignition coil in accordance with the operating instructions.  
Run the engine at idle.  
The measured primary voltage must be 300...350 V. See Fig.  
Voltage OK?

Replace trigger box.

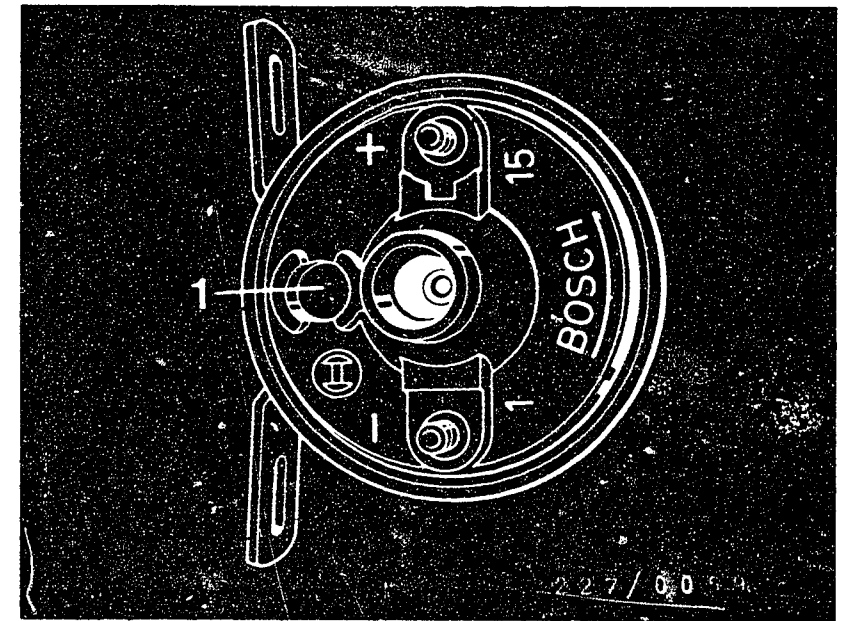
1 = Plug

Visual examination: Remove protective cap from ignition coil and check whether plug (see illustration) is in position and whether any sealing compound has escaped.

Electrical test: Ignition coil primary (term. 15 and 1)  $0.7...1.0 \Omega$  (take resistance of test lead with test prods into account).  
Ignition coil secondary (term. 1 and 4)  $6.7...9.6 k \Omega$ .

1. If plug is not in position and/or sealing compound has escaped, replace trigger box and ignition coil.

2. If resistance values are not O.K., replace ignition coil.

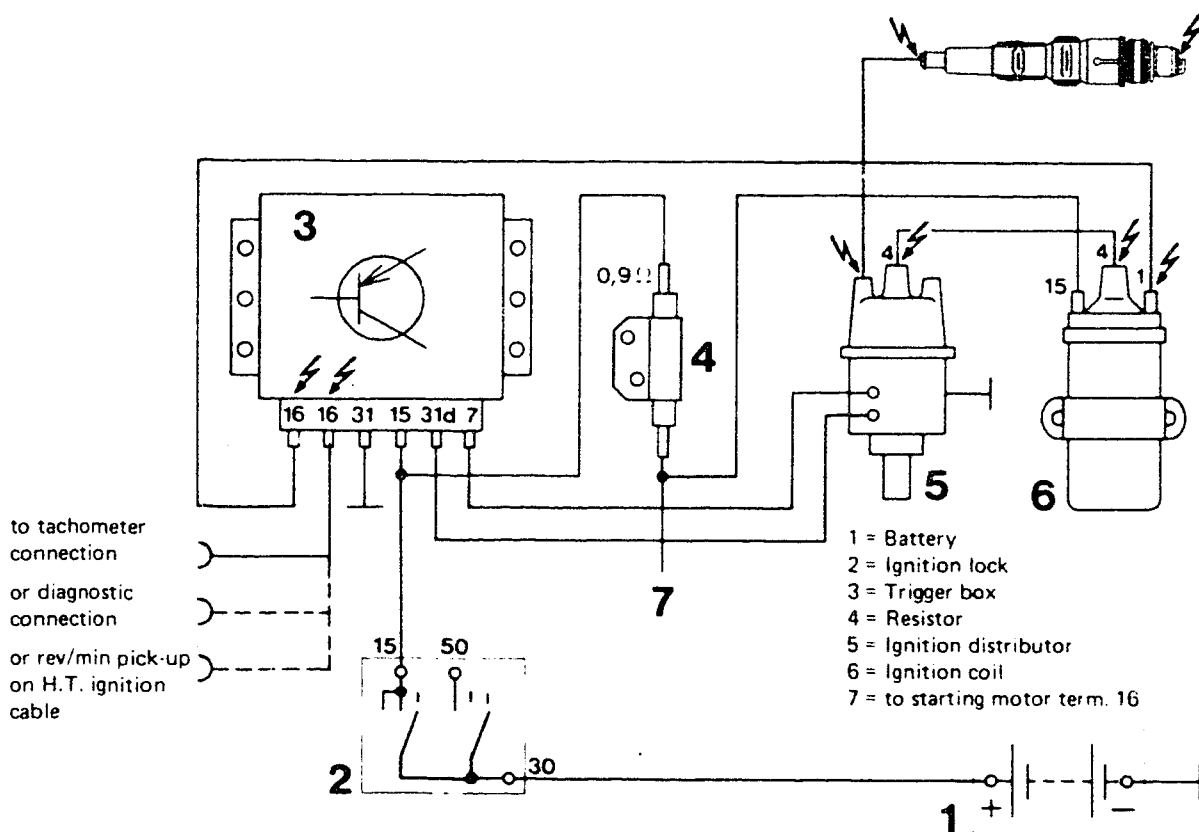
Terminal diagram

Below is a typical terminal diagram of a semi-conductor ignition system, the danger points are marked with red high-voltage arrows. We would point out that all semi-conductor ignition systems, even the older ones, are to be regarded as dangerous in the sense as defined by this bulletin.

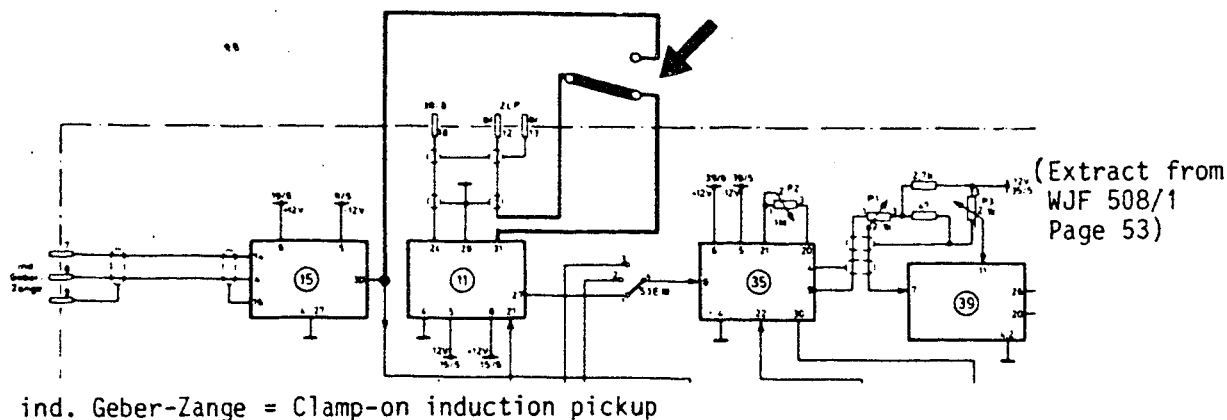
In comparison with conventional ignition systems, transistorized ignition systems with current limitation have different primary voltage characteristics. During the dwell period the voltage at terminal 1 of the ignition coil may assume values from 1.5 V to battery voltage (or greater). This may lead to an incorrect display of rotational speed and dwell angle as well as to incorrect triggering of the meter when testing the ignition system. There is, however, no functional defect in the ignition system, and, for this reason, the trigger box must not be replaced. Since, with the above-listed motortesters, the timing light is triggered by the signal path dwell angle - meter, this incorrect triggering also leads to incorrect flashing and thus to an incorrect display of the advance angle.

Remove the line of the ZLP\* from pin 31 of printed board 11 (coupling stage) and connect to pin 30 of printed board 15 (pulse shaper stage) via a switch with change-over contact (e.g. 0 341 500 803). In addition, a new line must be connected from pin 31 of printed board 11 to the other contact of the switch with change-over contact. Arrow points to switch with change-over contact.
